BUILDING ENVELOPE EVALUATION REPORT

SUMTER COUNTY COURTHOUSE

209 North Florida Street
Bushnell, FL 33513-6146

January 12, 2010

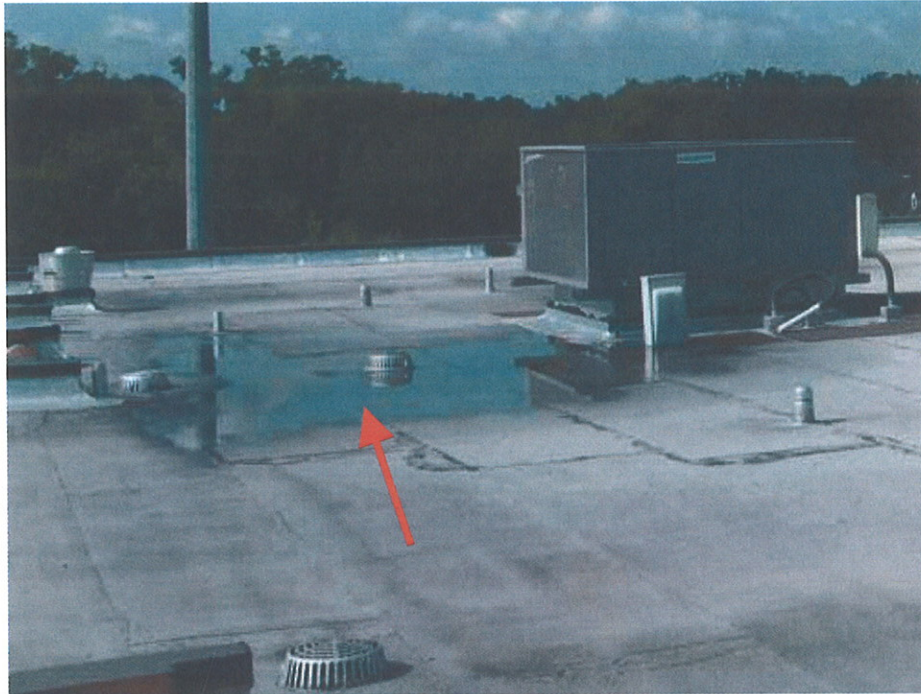
PONDING ON MODIFIED BITUMINOUS MEMBRANE. PONDING WILL CAUSE PREMATURE DETERIORATION OF MEMBRANE. MOST OF THE PONDING APPEARS TO BE THE RESULT OF CLOGGED ROOF DRAINS.

- 5.1 Conduct roof maintenance including the cleaning of all roof drains..
- 5.2 Contact the manufacturer of the roof membrane to provide a written report of the roof condition and include any required repairs or maintenance necessary to maintain the current roof warranty.

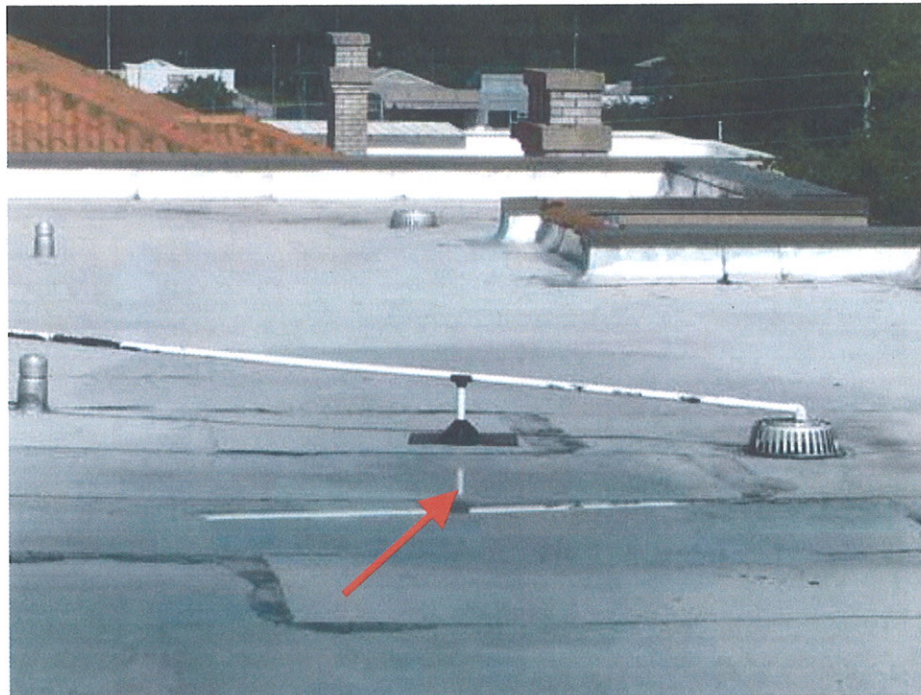
MINOR PONDING ON MODIFIED BITUMINOUS MEMBRANE.
